**DEPARTMENT OF TRANSPORTATION**

Contract #: 04-0120F4Cty: SF/ALA Rte: 80 PM: 13.2/13.9File #: 1.28**WELDING INSPECTION REPORT****Resident Engineer:** Casey, William**Address:** 333 Burma Road**City:** Oakland, CA 94607**Report No:** WIR-026519**Date Inspected:** 13-Oct-2011**Project Name:** SAS Superstructure**OSM Arrival Time:** 700**Prime Contractor:** American Bridge/Fluor Enterprises, a JV**OSM Departure Time:** 1730**Contractor:** American Bridge/Fluor Enterprises, a JV**Location:** Job Site

**Bridge No:** 34-0006**Component:** SAS Tower**Summary of Items Observed:**

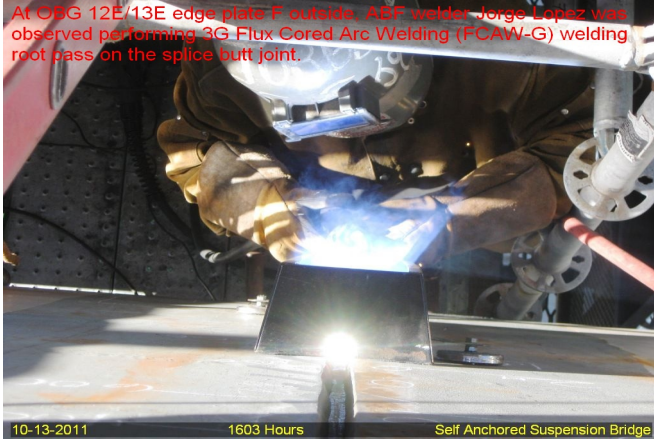
10-13-2011 1603 Hours Self Anchored Suspension Bridge

At OBG 12E/13E edge plate 'F' outside, QA randomly observed ABF/JV qualified welder Jorge Lopez perform root pass welding on the Complete Joint Penetration (CJP) splice butt joint. The welder was observed manually welding in the 3G (vertical) position utilizing a dual shield Flux Cored Arc Welding (FCAW-G) with E71T-1M, 1/16" diameter wire electrode implementing Caltrans approved Welding Procedure Specification (WPS) ABF-WPS-D15-3040B-3. The joint being welded has a single V-groove butt joint with steel backing bar. ABF Quality Control (QC) Fred Von Hoff was noted monitoring the welding parameters of the welder. QA randomly monitored the welding parameter with reading of 250 amperes, 22.5 volts which appears in conformance to the contract requirements. At the end of the shift, FCAW root pass welding was still continuing and should remain tomorrow.

At OBG 12E/13E edge plate F outside, ABF welder Jorge Lopez was observed performing 3G Flux Cored Arc Welding (FCAW-G) welding root pass on the splice butt joint.

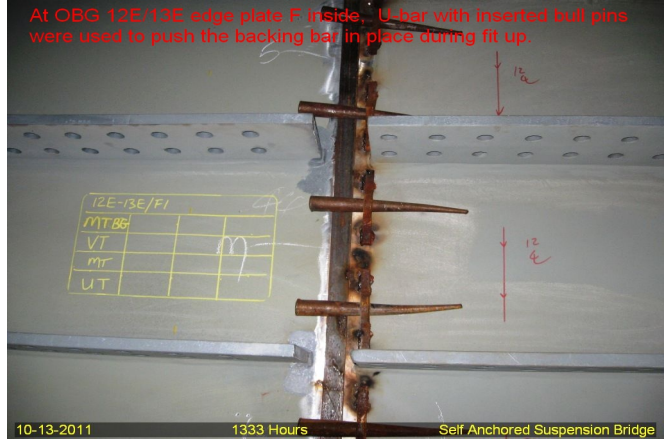
10-13-2011 1333 Hours Self Anchored Suspension Bridge

Prior welding, fellow QA Craig Hager has verified the fit up alignment with noted 2mm to 6mm offset from top (110 mm long) and 2mm to 5mm offset to the bottom (220mm long). The backing bar gap to the edge plate was originally measured 2mm to 9mm (from bottom 580mm long) but this was fixed by pushing the bull pins. According to ABF QC Supervisor Bonifacio Daquinag, the misalignment on the top and bottom will be mapped and recorded and then submitted to ABF for review.

At OBG 12E/13E edge plate F inside, U-bar with inserted bull pins were used to push the backing bar in place during fit up.
